# X線反射率法を用いたパターン媒体の 加工ダメージ評価

#### (株)東芝 研究開発センター 喜々津 哲

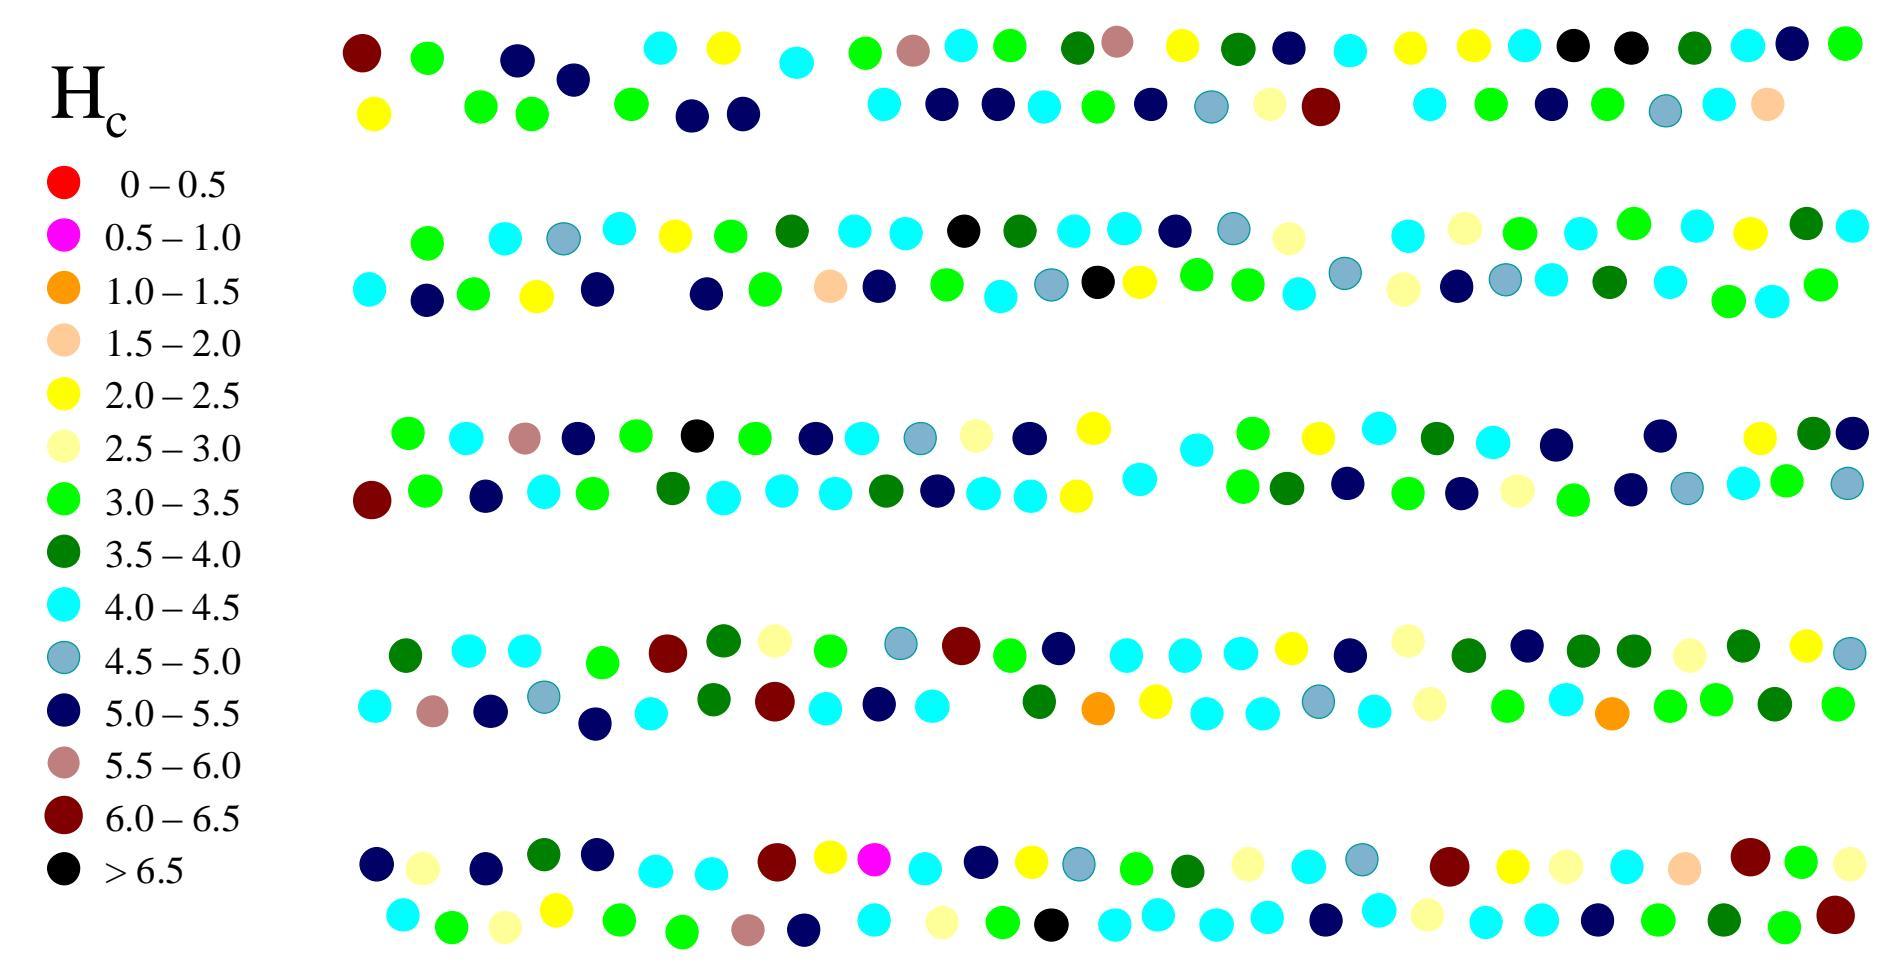
# 各ドットの保磁力分布

Hc distribution of aligned CoCrPt dots  $(40 \text{nm}\phi)$

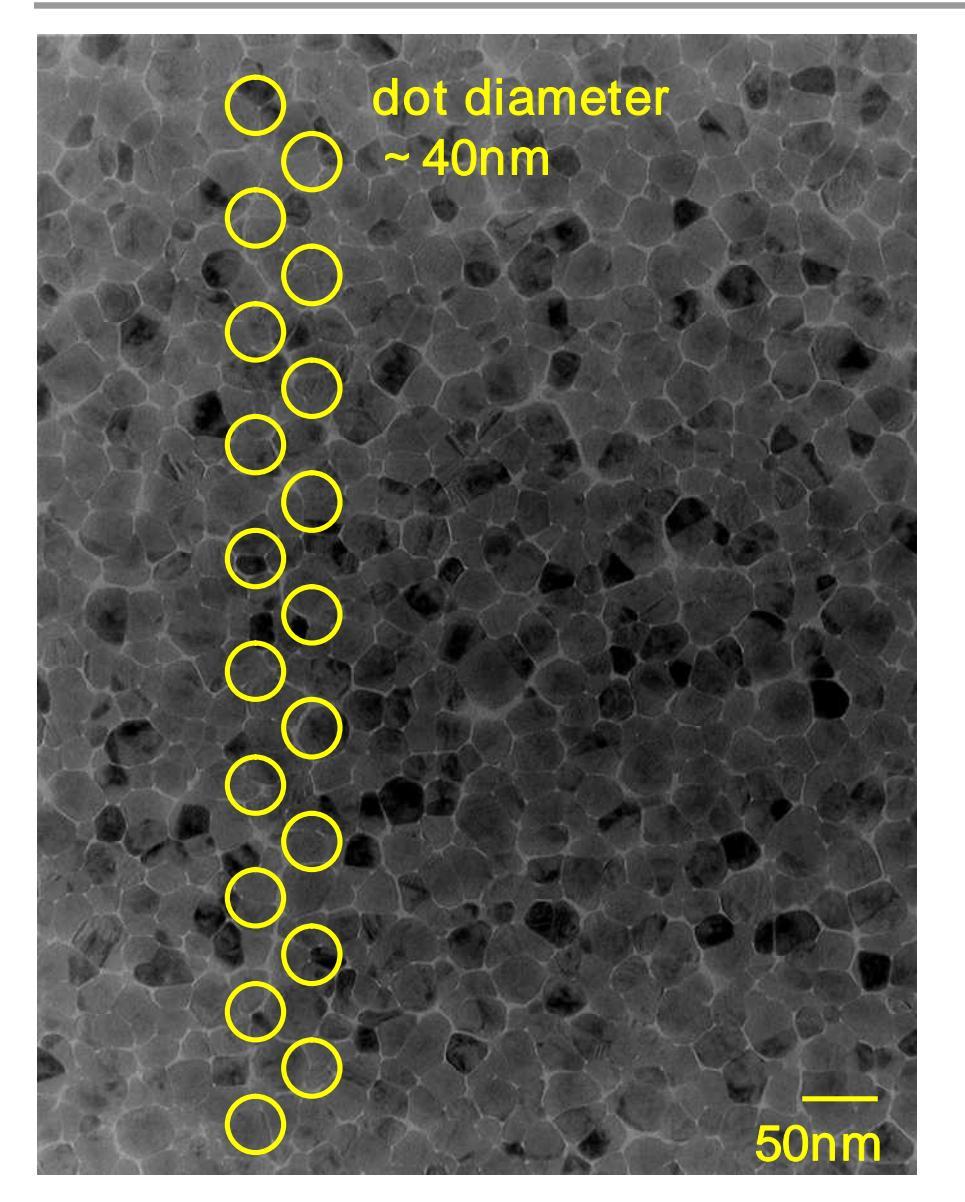
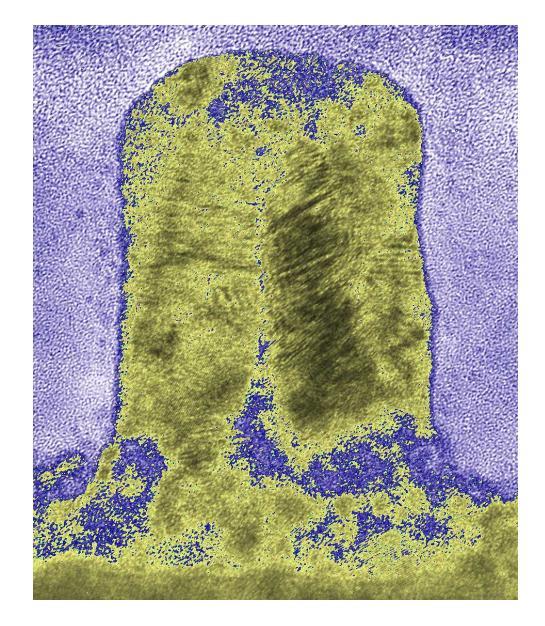
# ドットの均一性:数本の粒界、異方性軸分布

磁性膜の平均粒径: 22.9 nm パターンサイズ: 40 nm ドット中に粒界が1-2個

垂直配向軸のばらつき、

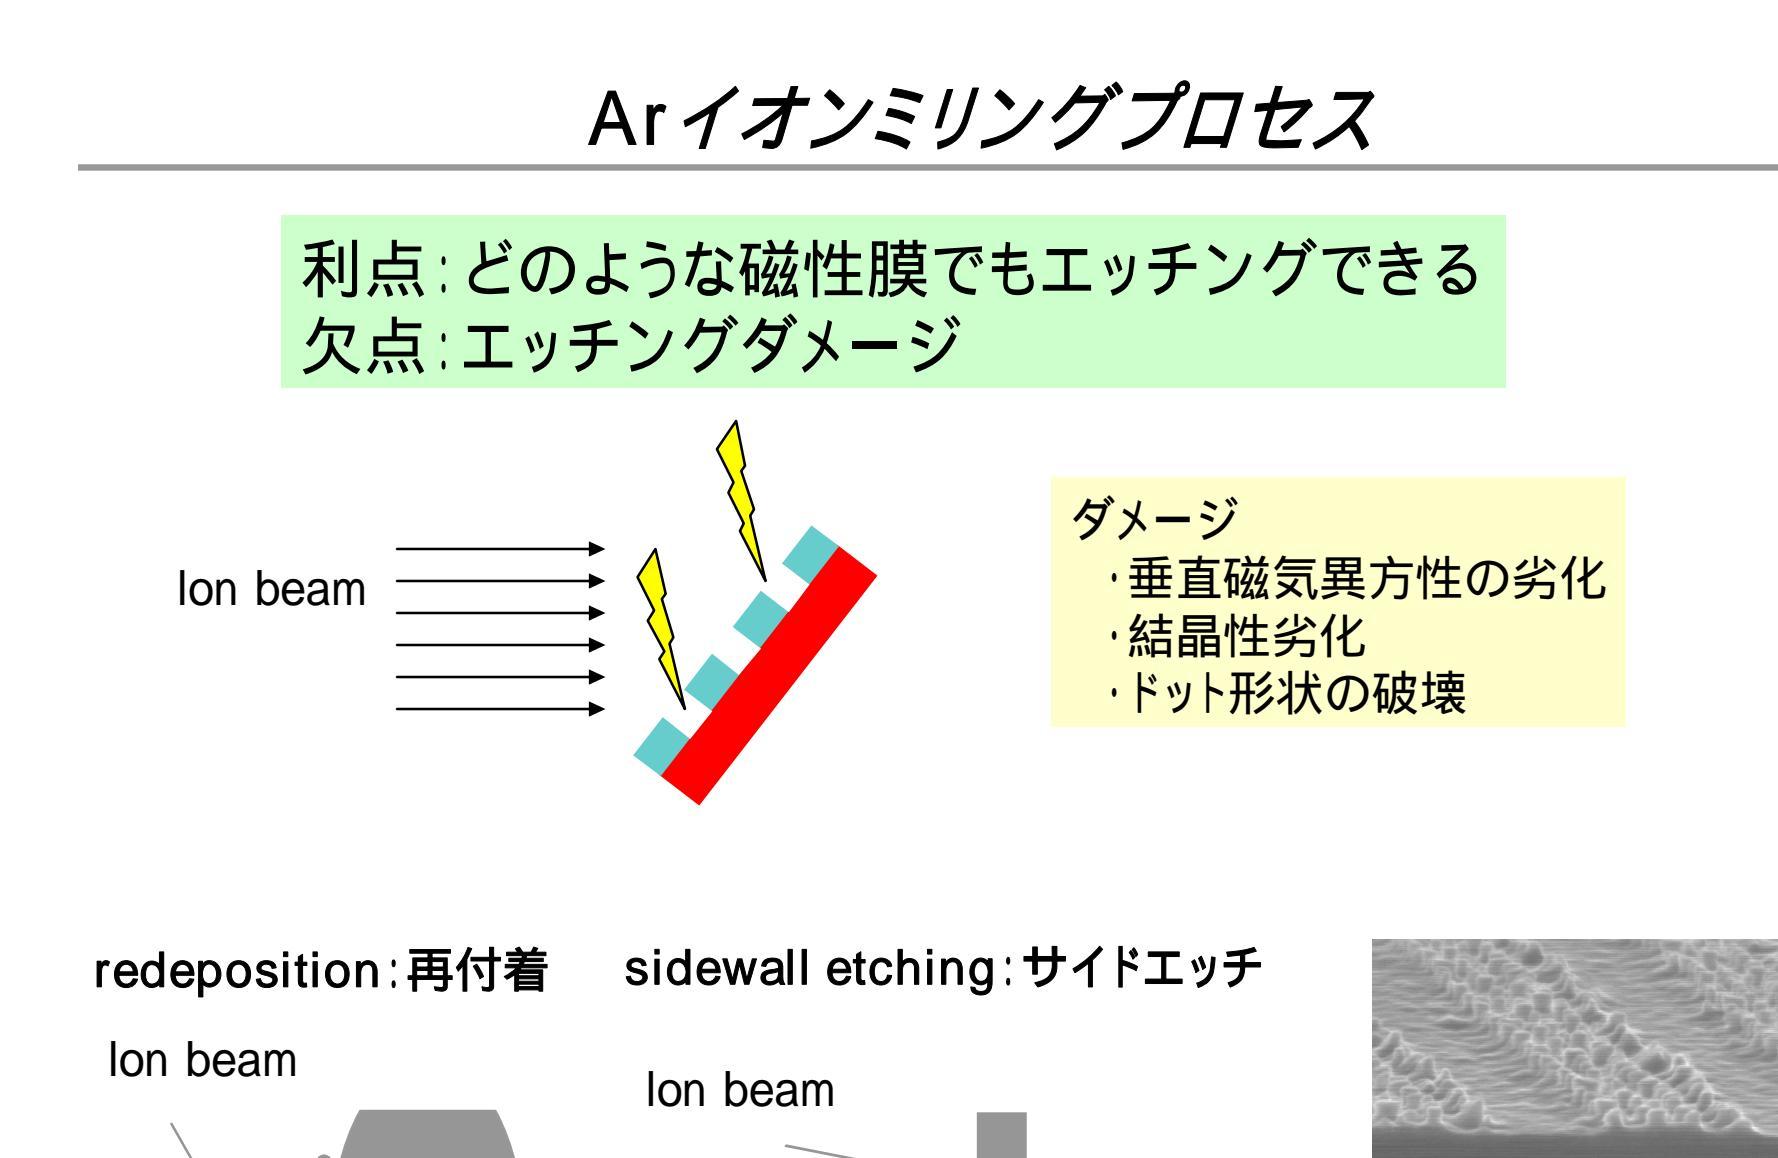
- >dot size distribution
- microscopic composition dispersion
- ➢ grain boundary
- >damage by the etching process
  - ... TEM, simulation: little damage by ion milling

**Back sputtering**

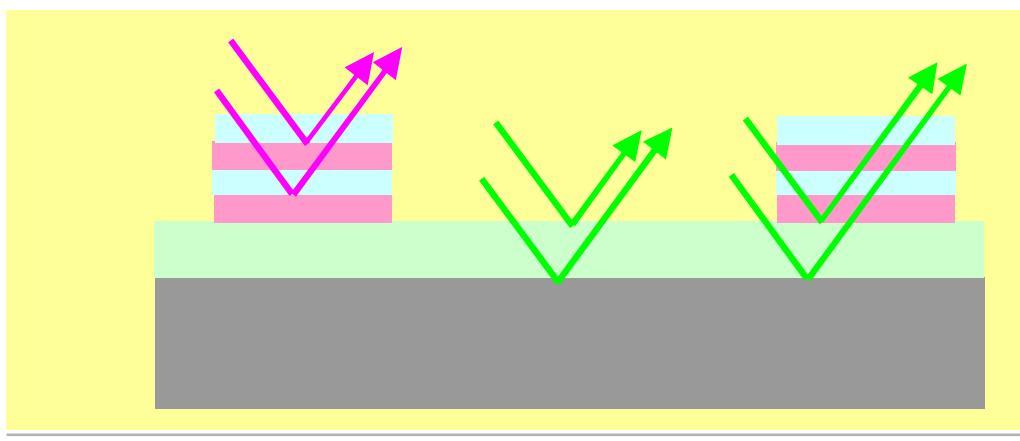
similar refraction is expected; multilayer: reduced intensity underlayer: increased intensity dot edge: scattering

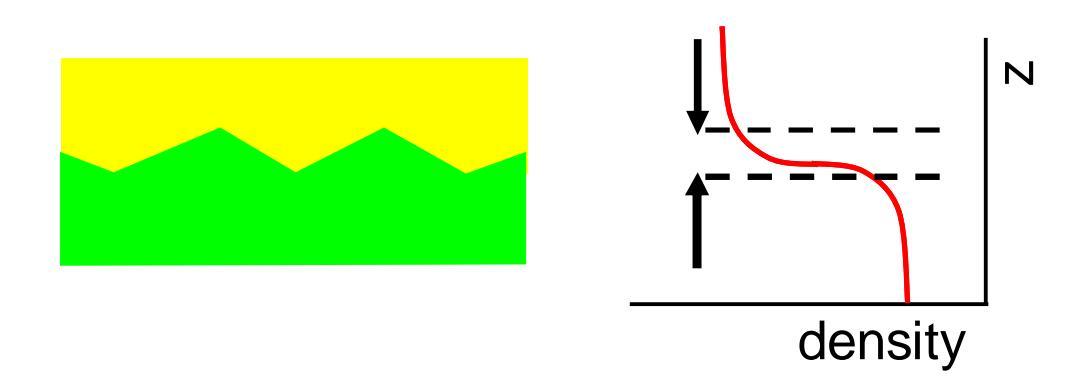
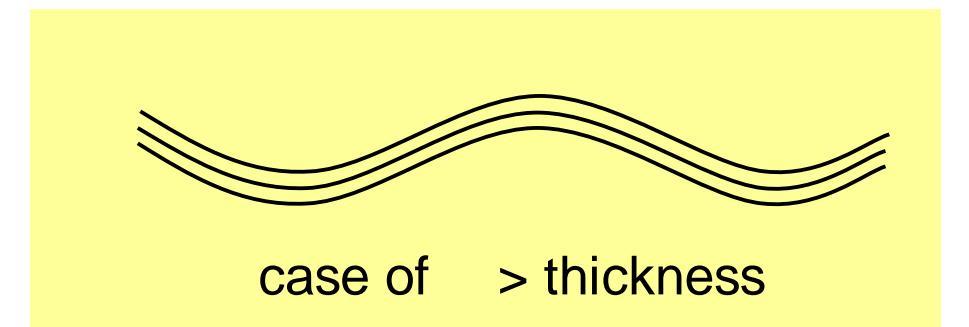
# Fitting model; roughness

rough interface → gradual density change: (z) (z): error function

$$\rho(z) = \frac{1}{\sqrt{\pi}} \int_{-\infty}^{z} \exp(-\frac{t^2}{2\sigma^2}) \cdot dt$$

: roughness

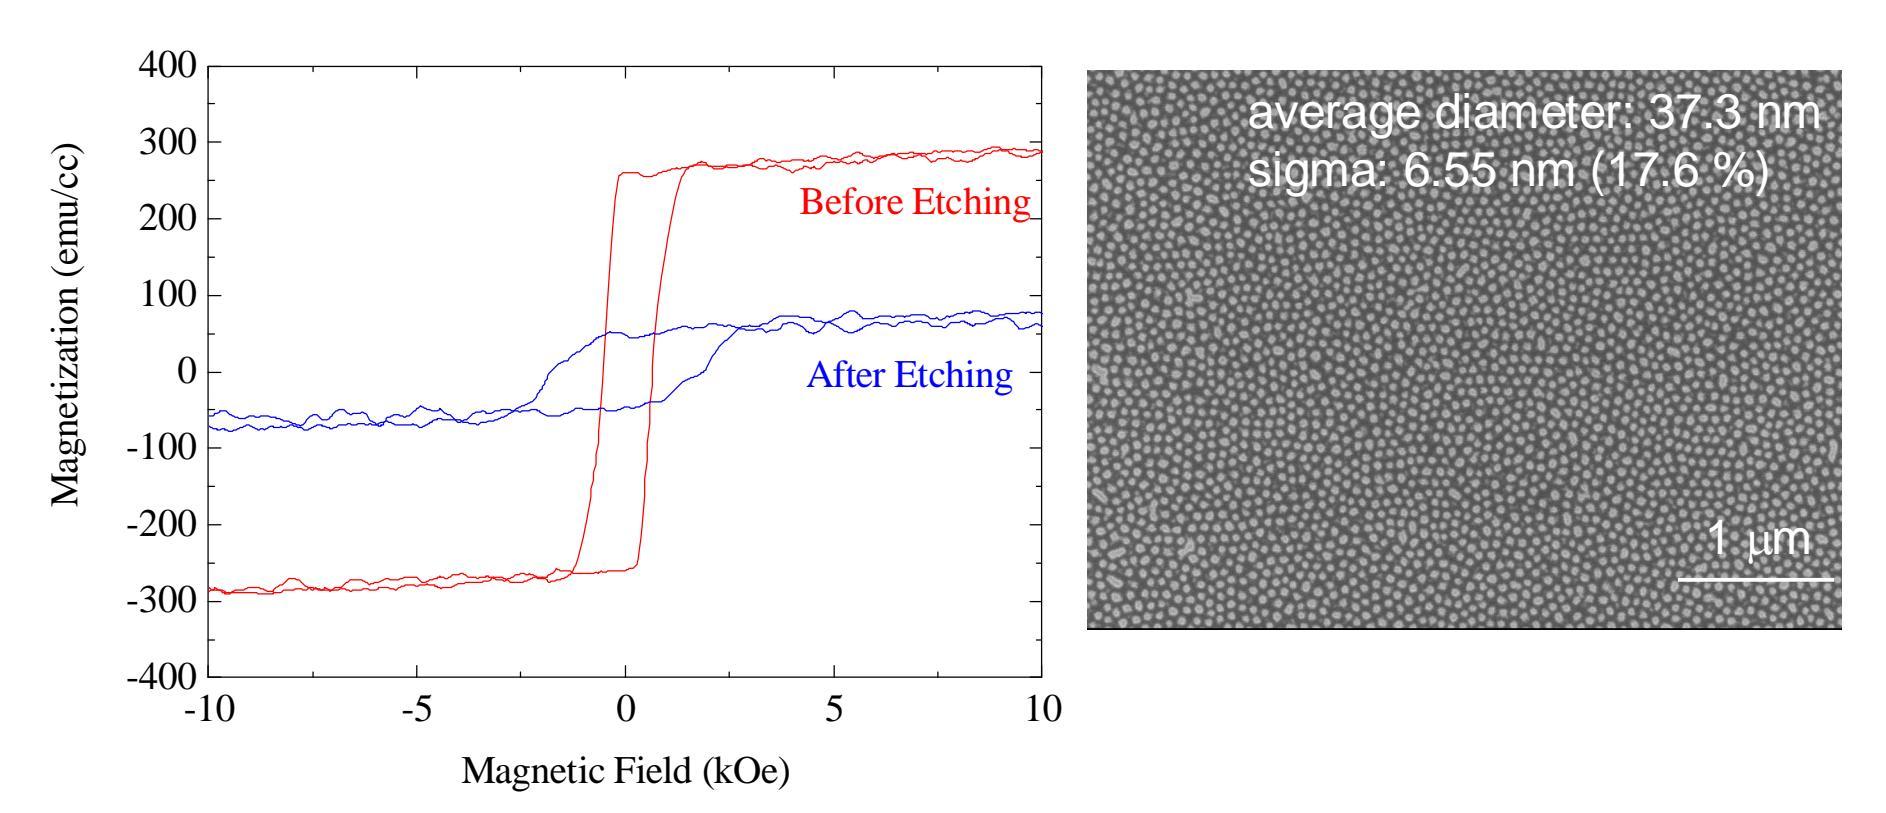
## magnetic properties

#### little damage to the magnetic properties

- reduction in M<sub>s</sub>: proportional to the packing density
- K<sub>u</sub> (by torque curve amplitude): no change

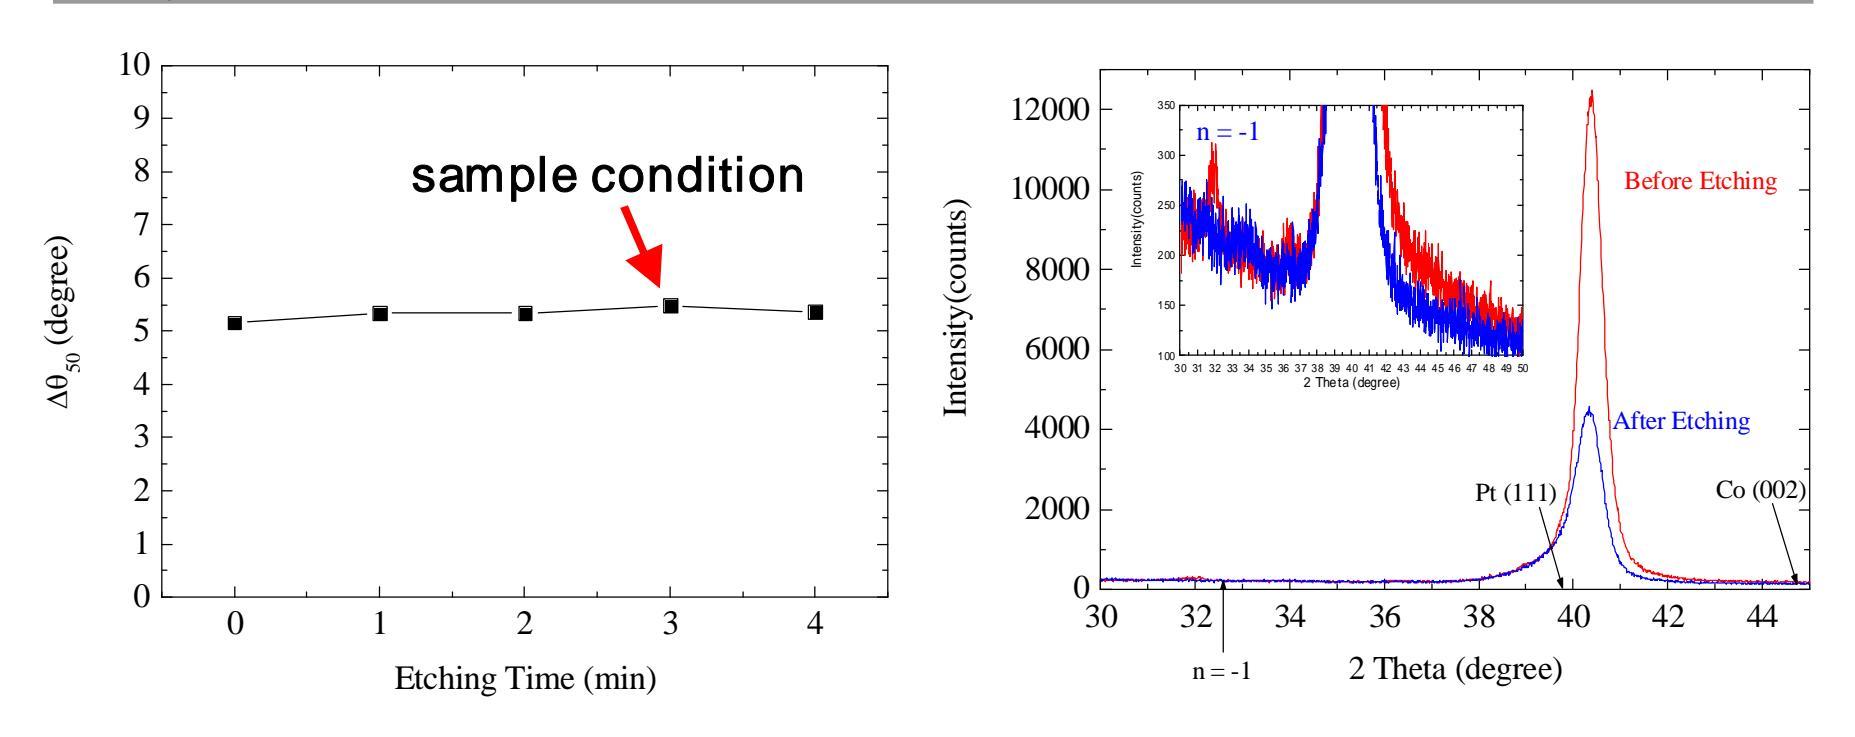
crystal properties (XRD:  $\theta$ -2 $\theta$ )

$\geq \Delta \theta_{50}$ : little change throughout the etching process

$\geq \theta$ -2 $\theta$ : - reduced intensity by volume reduction

- before etching: satellite peak from multilayer structure
- after etching: no satellite peak -> damage?

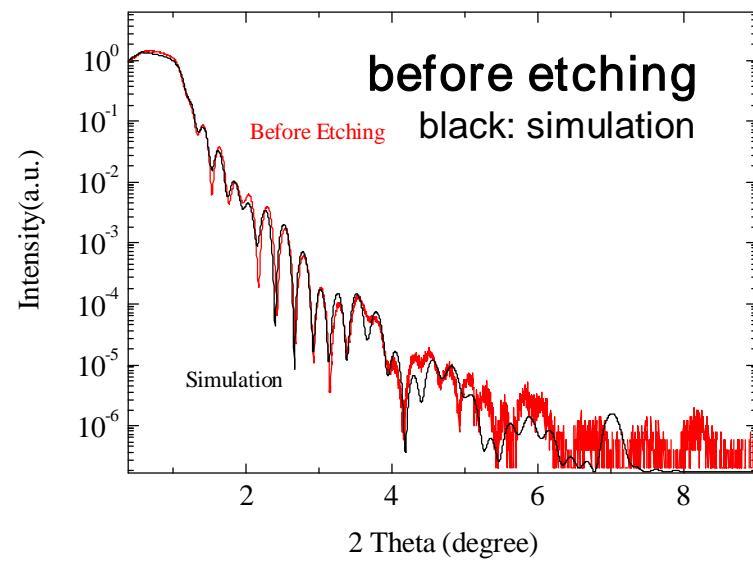
Nominal thickness (nm)	Fitting thickness (nm)	Roughness (nm)
Top Pt	0.9	0.90	0.90
[Co/Pt] <sub>20</sub>	0.3/0.9	0.37/0.90	0.45/0.90
Та	8.0	7.45	0.50
Glass Sub.			0.5

- good agreement with nominal thickness

- roughness ~1nm at [Co/Pt] and top

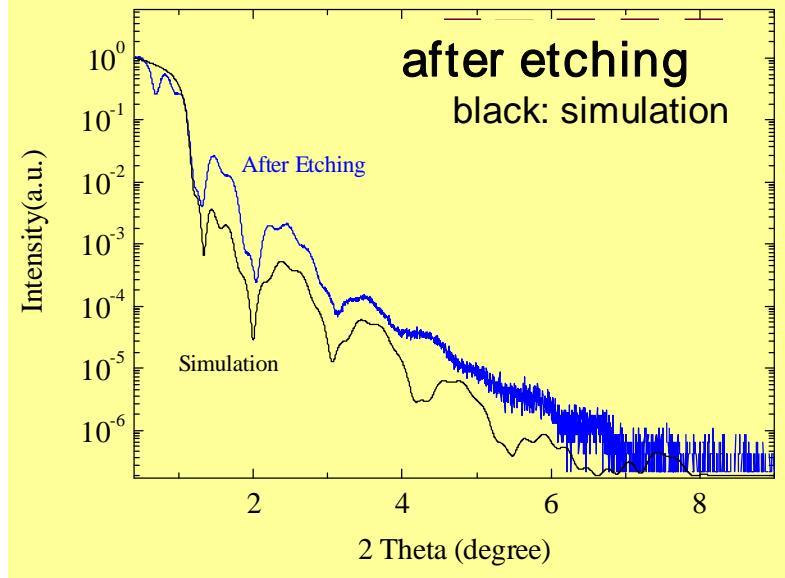
Nominal thickness (nm)	Fitting thickness (nm)	Roughness (nm)
	Top Pt	0.9	0.80	3.80
	[Co/Pt] <sub>20</sub>	0.3/0.9	0.38/0.80	0.45/0.90
	Та	8.0	7.40	0.55
	Glass Sub.			0.5

little change in ML structure (roughness)
large roughness at the top Pt layer

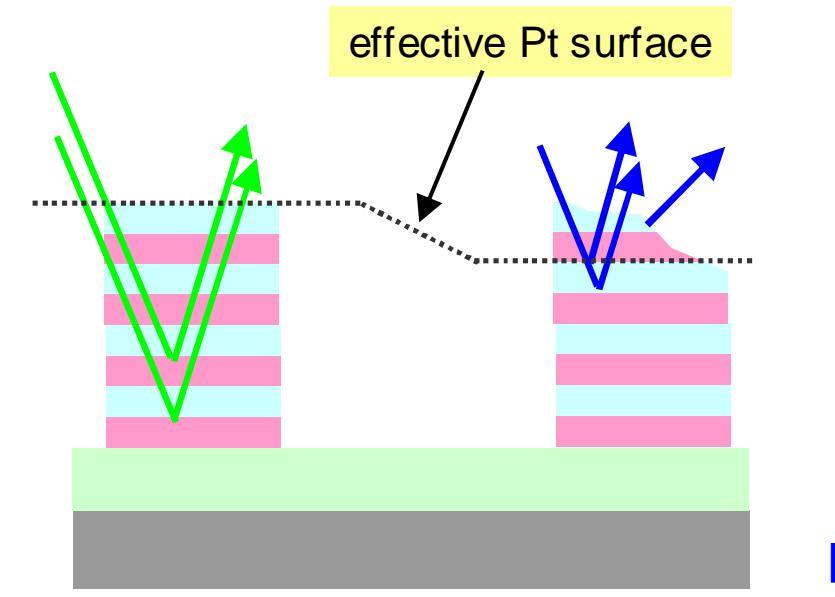
# origin of the large surface roughness

chipped dots but smooth ML structure

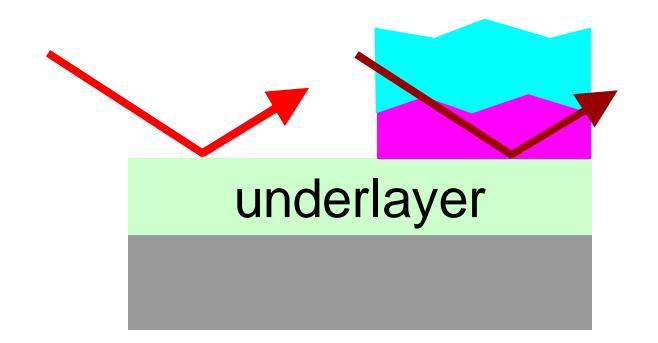
#### Issue: strong reflection from the etched-out region

difference in reflectivity of underlayer between etch-out region and dot region

➔ Analytical estimation is difficult.

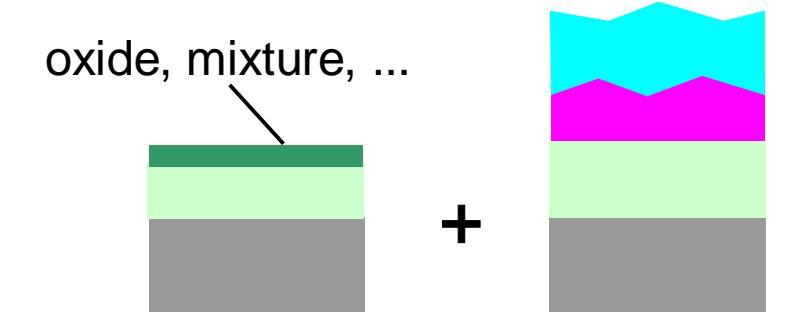
Summation of two spectra (or subtraction) could work well.
